WATER QUALITY STUDY
OF THE
EAST FORK LITTLE SANDY RIVER

February 1992

KENTUCKY DEPARTMENT FOR ENVIRONMENTAL PROTECTION
DIVISION OF WATER
WATER QUALITY BRANCH

WATER QUALITY STUDY
OF THE
EAST FORK LITTLE SANDY RIVER
(MILE 25.4 TO MILE 17.0)

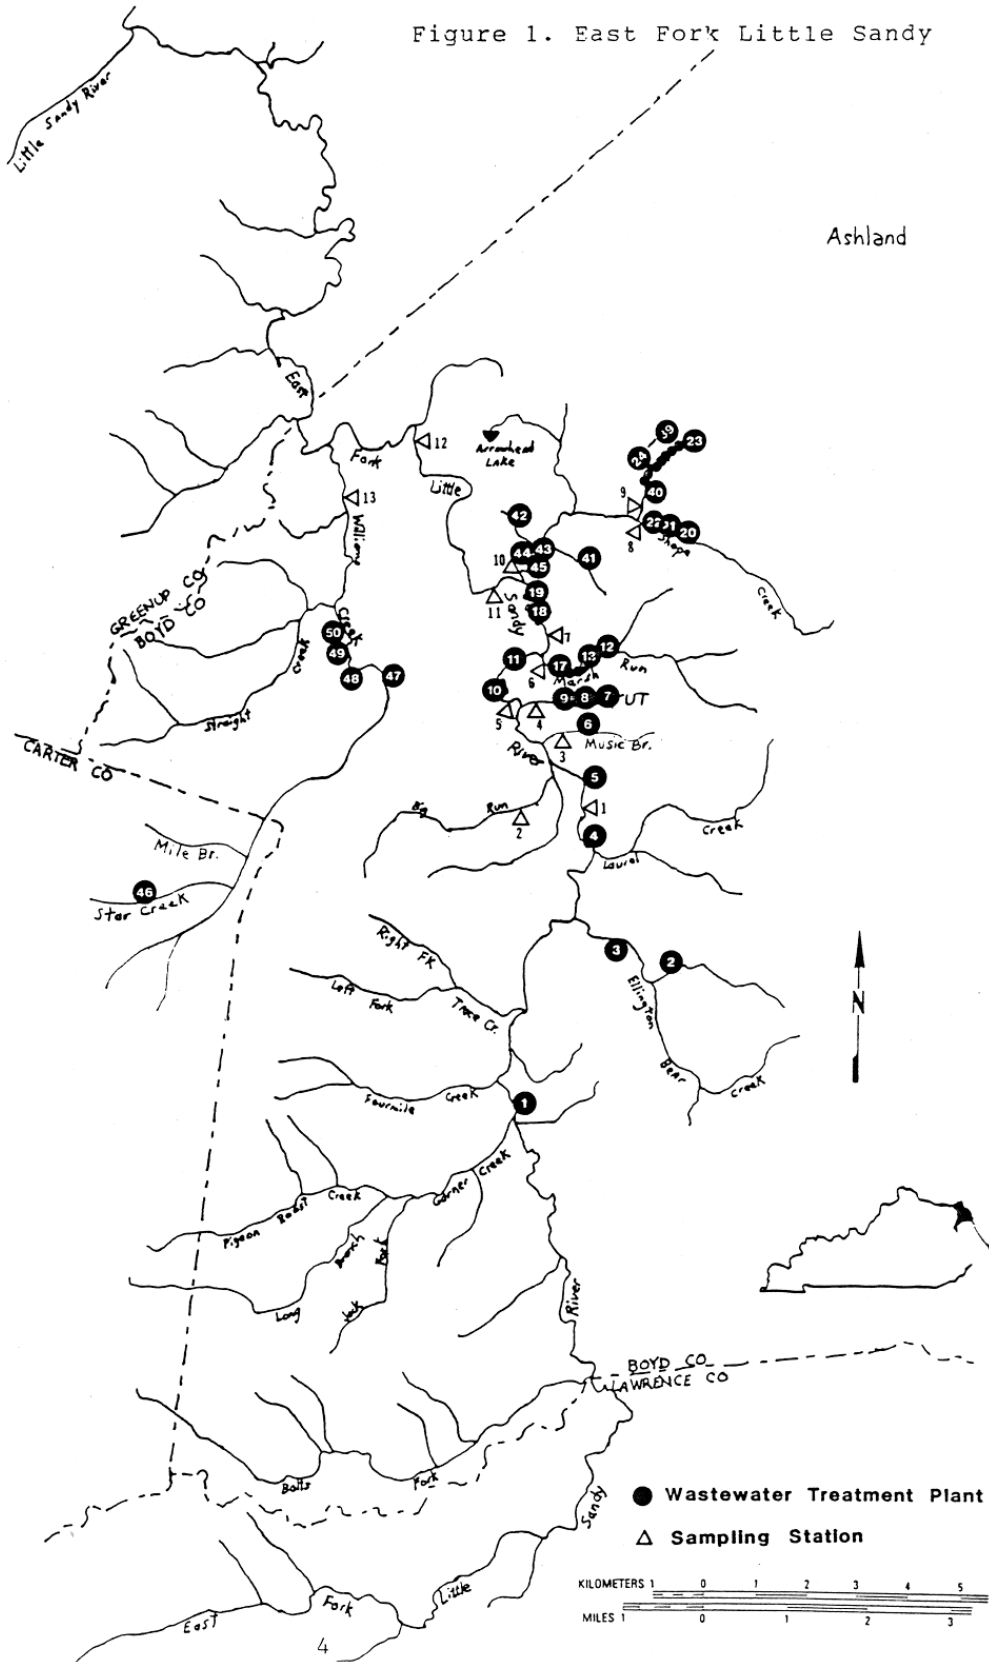
Figure 1. East Fork Little Sandy

Dissolved oxygen in the East Fork at mile 25.4 (Site 1 on Figure 1) was 4.6 mg/L on August 6 at 2:30 P.M. Normally, DO in the afternoon is much higher because of photosynthesis by algae. Weather conditions were cloudy, and there was oil on the water surface. These factors may have reduced photosynthetic activity at this site, but do not appear to have affected other sampling stations. This low DO may be the result of effluent from a mobile home park 0.6 miles upstream. This facility is known to have had operational problems in the past. In contrast, the DO in Big Run (Site 2) at mile 0.4 was 13.2 mg/L at 3:05 P.M., a clear indication of photosynthesis. Music Branch (Site 3) and the unnamed tributary
